REPORT NUMBER 214-GTL-04-003

**SAFETY COMPLIANCE TESTING FOR  
FMVSS NO. 214S  
SIDE IMPACT PROTECTION (STATIC)**

**GENERAL MOTORS CORP.  
2004 CHEVROLET MALIBU, PASSENGER CAR  
NHTSA NO. C40102**

**GENERAL TESTING LABORATORIES, INC.  
1623 LEEDSTOWN ROAD  
COLONIAL BEACH, VIRGINIA 22443**

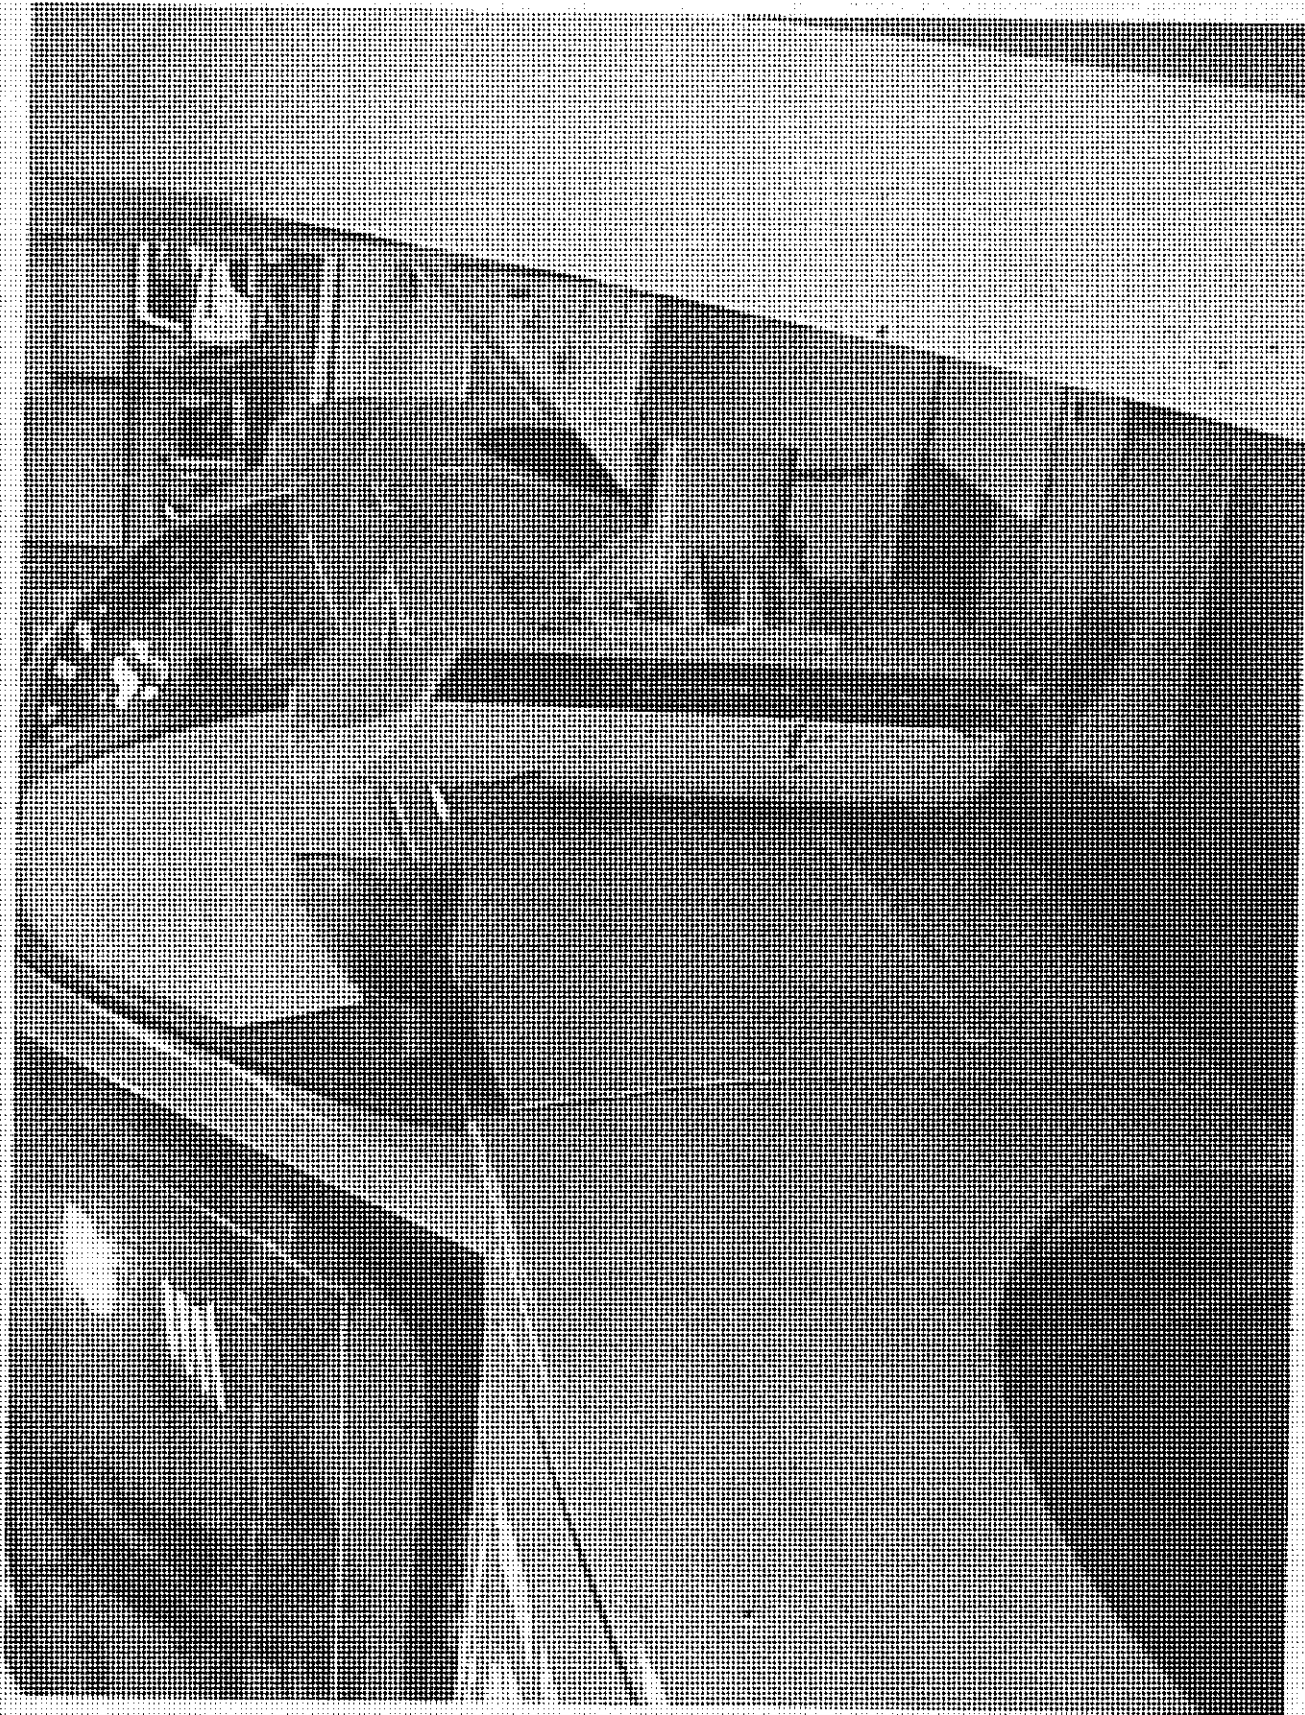
FIGURE 5.15  
LOAD DEVICE AGAINST DOOR - PRE-  
TEST 1

| SECTION | | PAGE |
|---|---|---|
| | 5.15 Load Device against Door - Pre-Test 1 | |

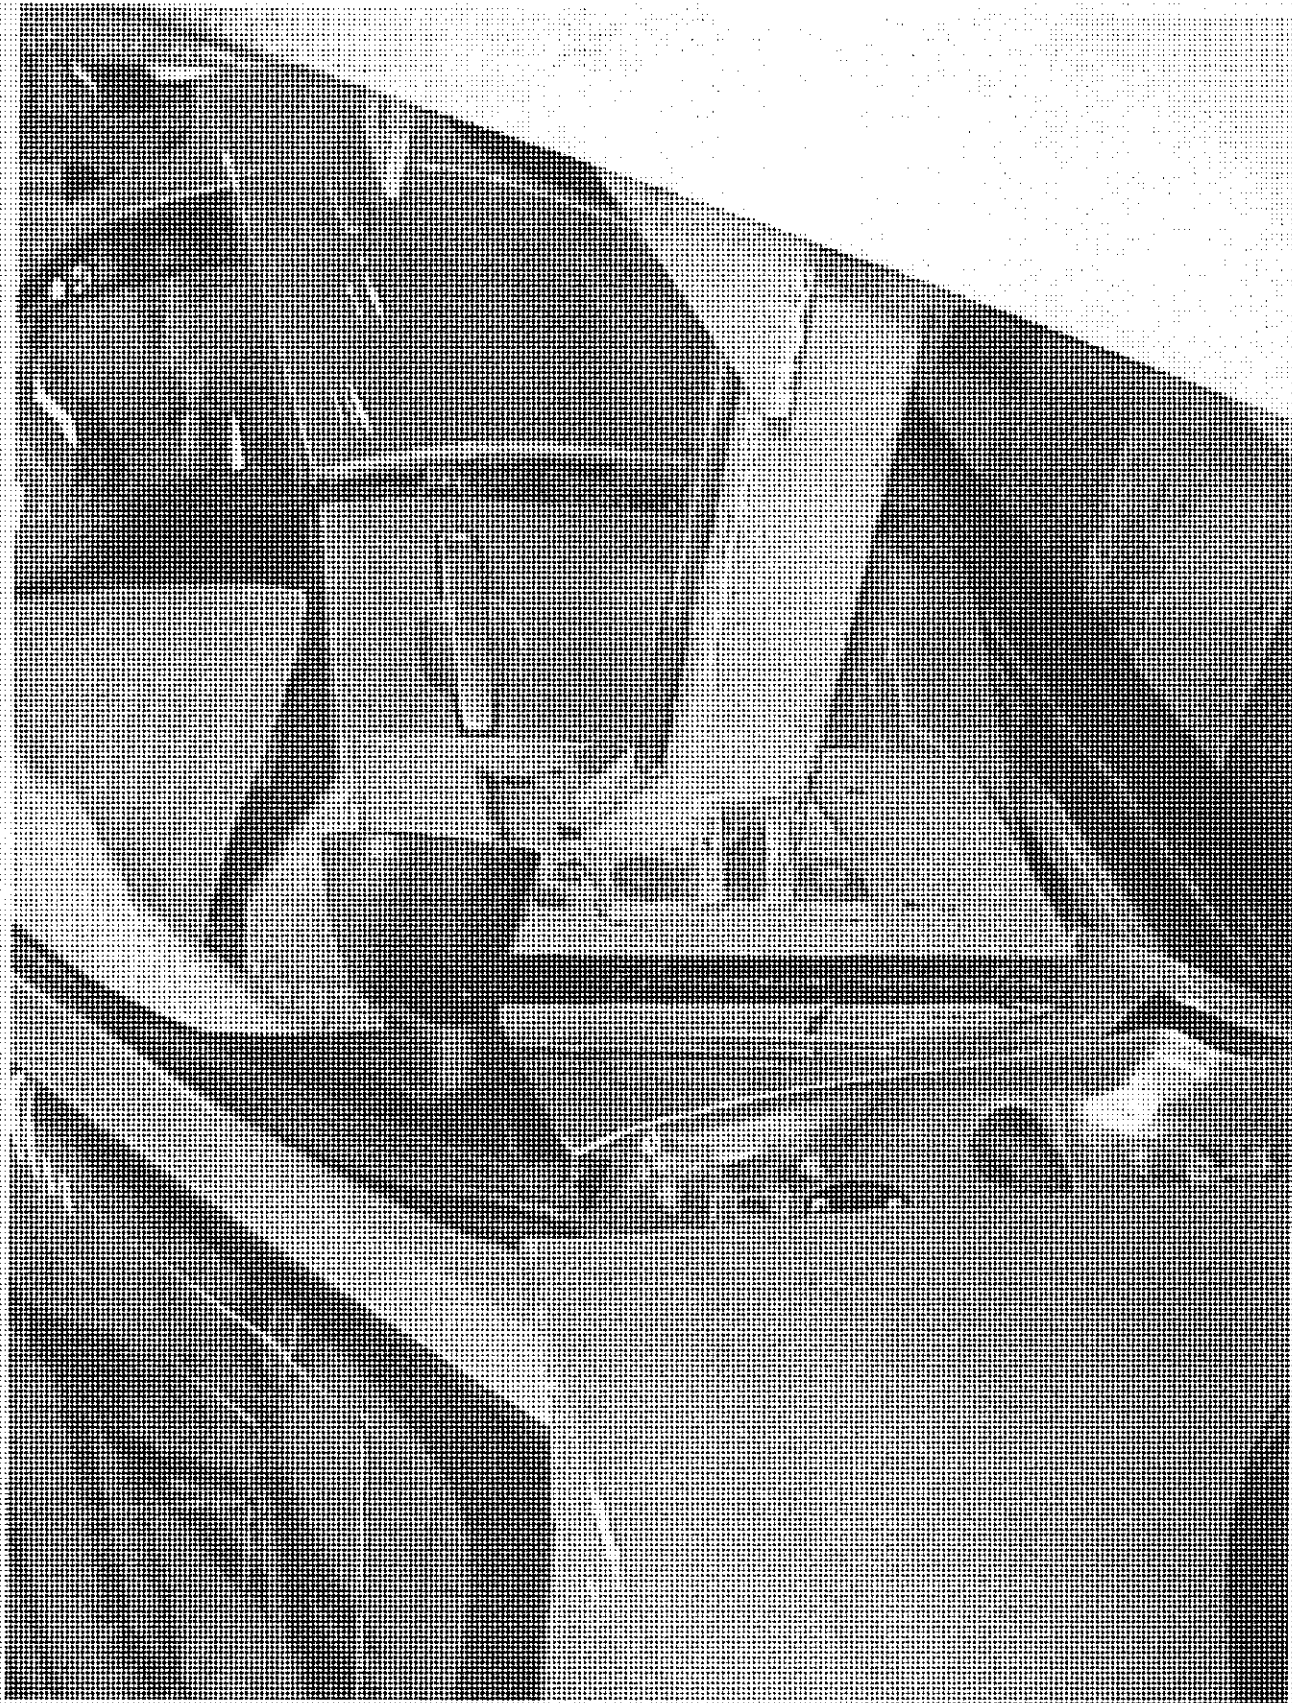
FIGURE 3.16  
LOAD DEVICE AGAINST DOOR @ MAX  
LOAD - TEST 1

| SECTION | | PAGE |
|---|---|---|
| | 5.16 Load Device against Door @ max load - Test 1 | |

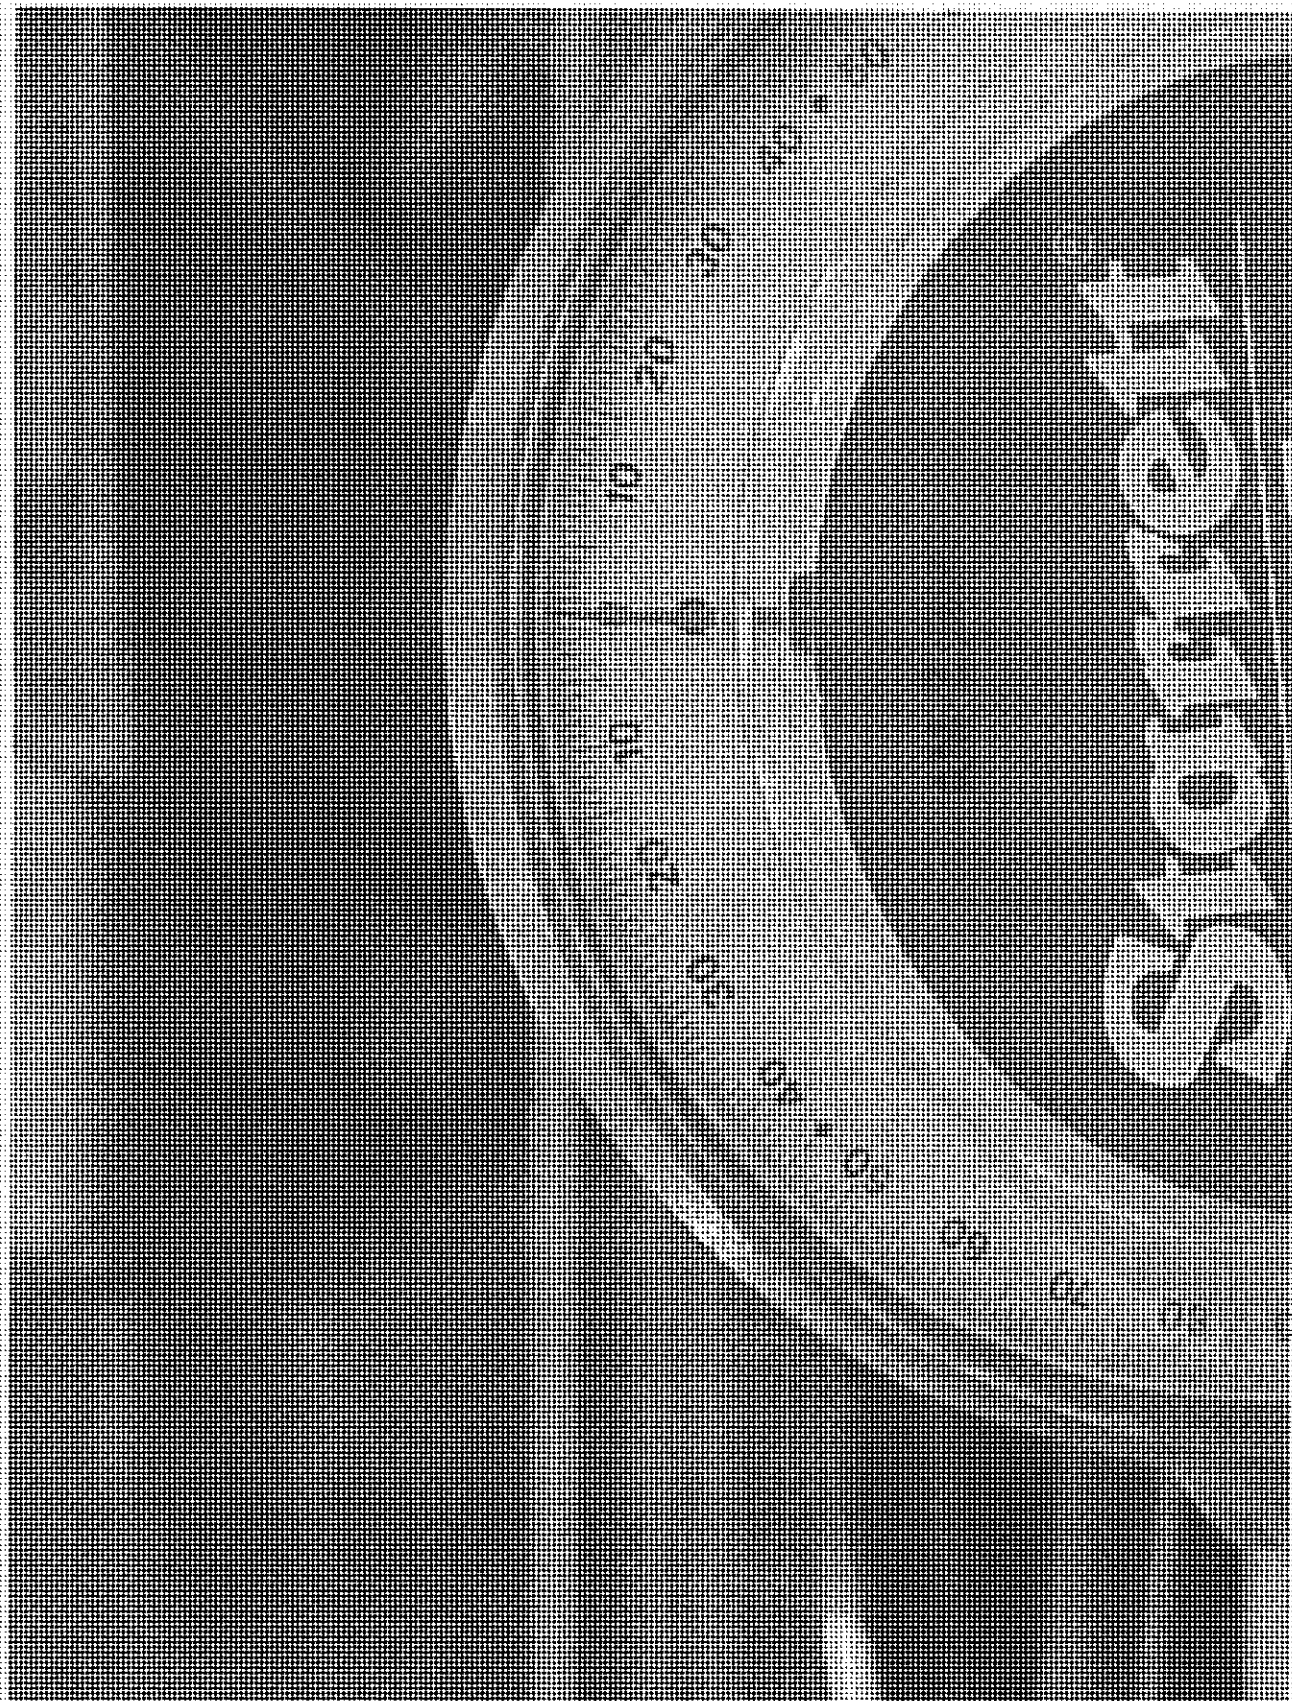
FIGURE 5.17  
INCLINOMETER AT MAX LOAD - TEST 1

| SECTION | | PAGE |
|---|---|---|
| | 5.17 Inclinator at Max Load - Test 1 | |

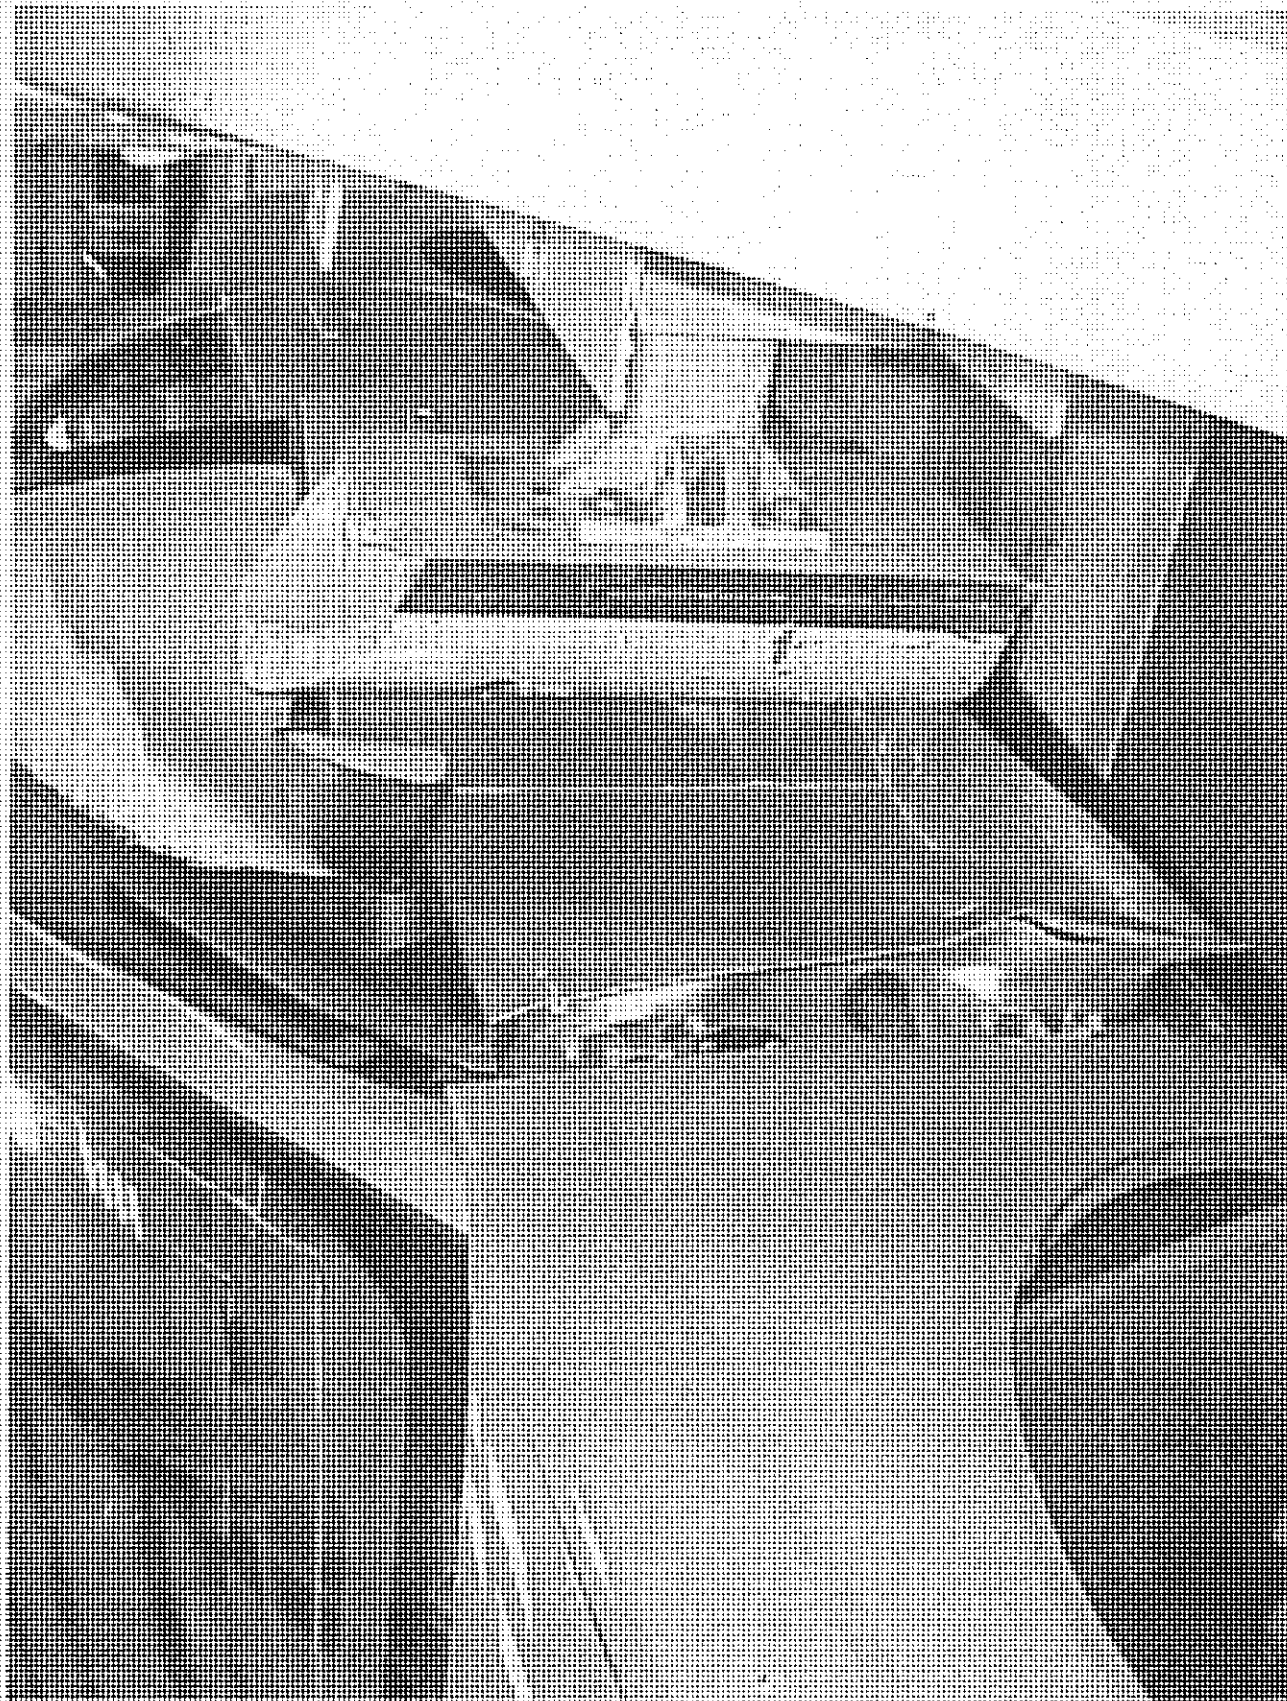
FIGURE 5.19  
POST TEST DOOR OUTSIDE - TEST 1

| SECTION | | PAGE |
|---|---|---|
| | 5.19 Post Test Door Outside - Test 1 | |

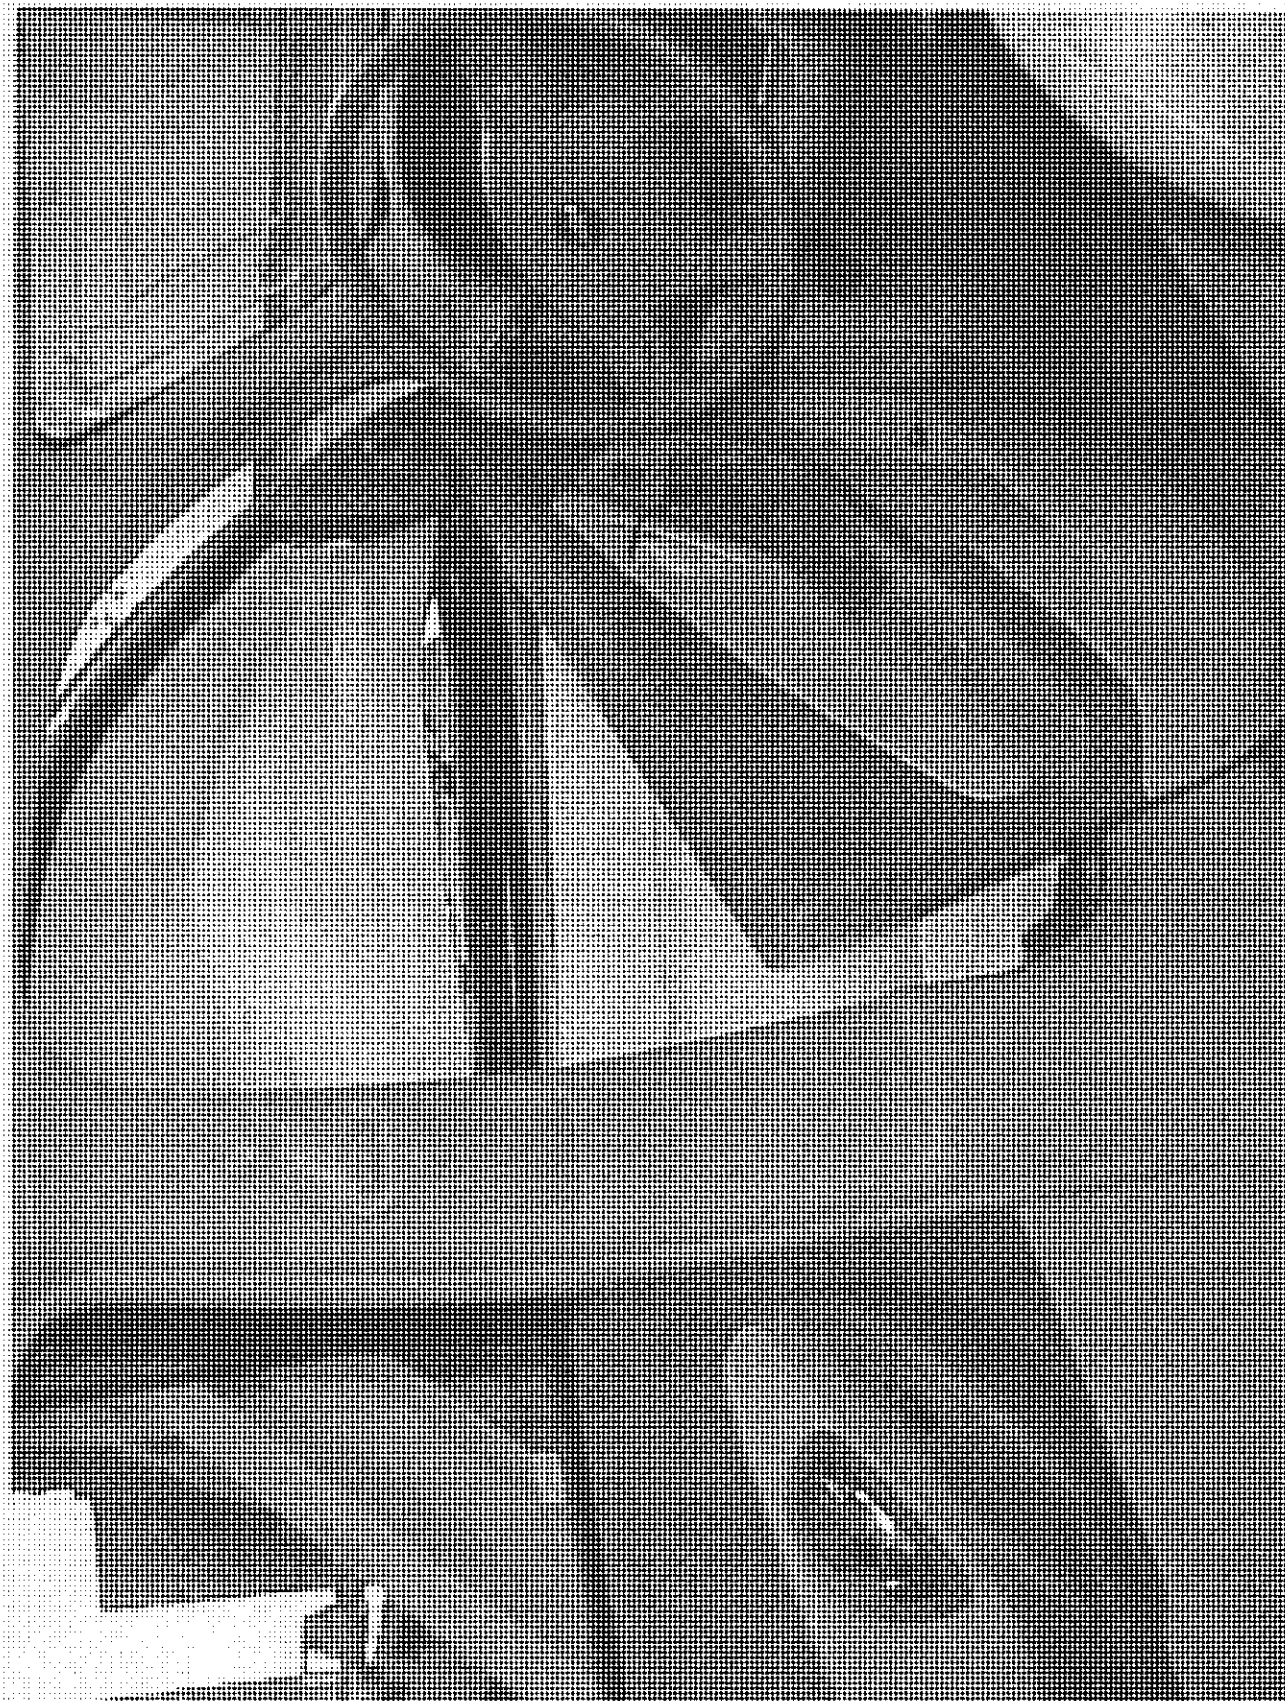
FIGURE 5.20  
POST TEST DOOR INSIDE - TEST 1

| SECTION | | PAGE |
|---|---|---|
| | 5.20 Post Test Door Inside - Test 1 | |

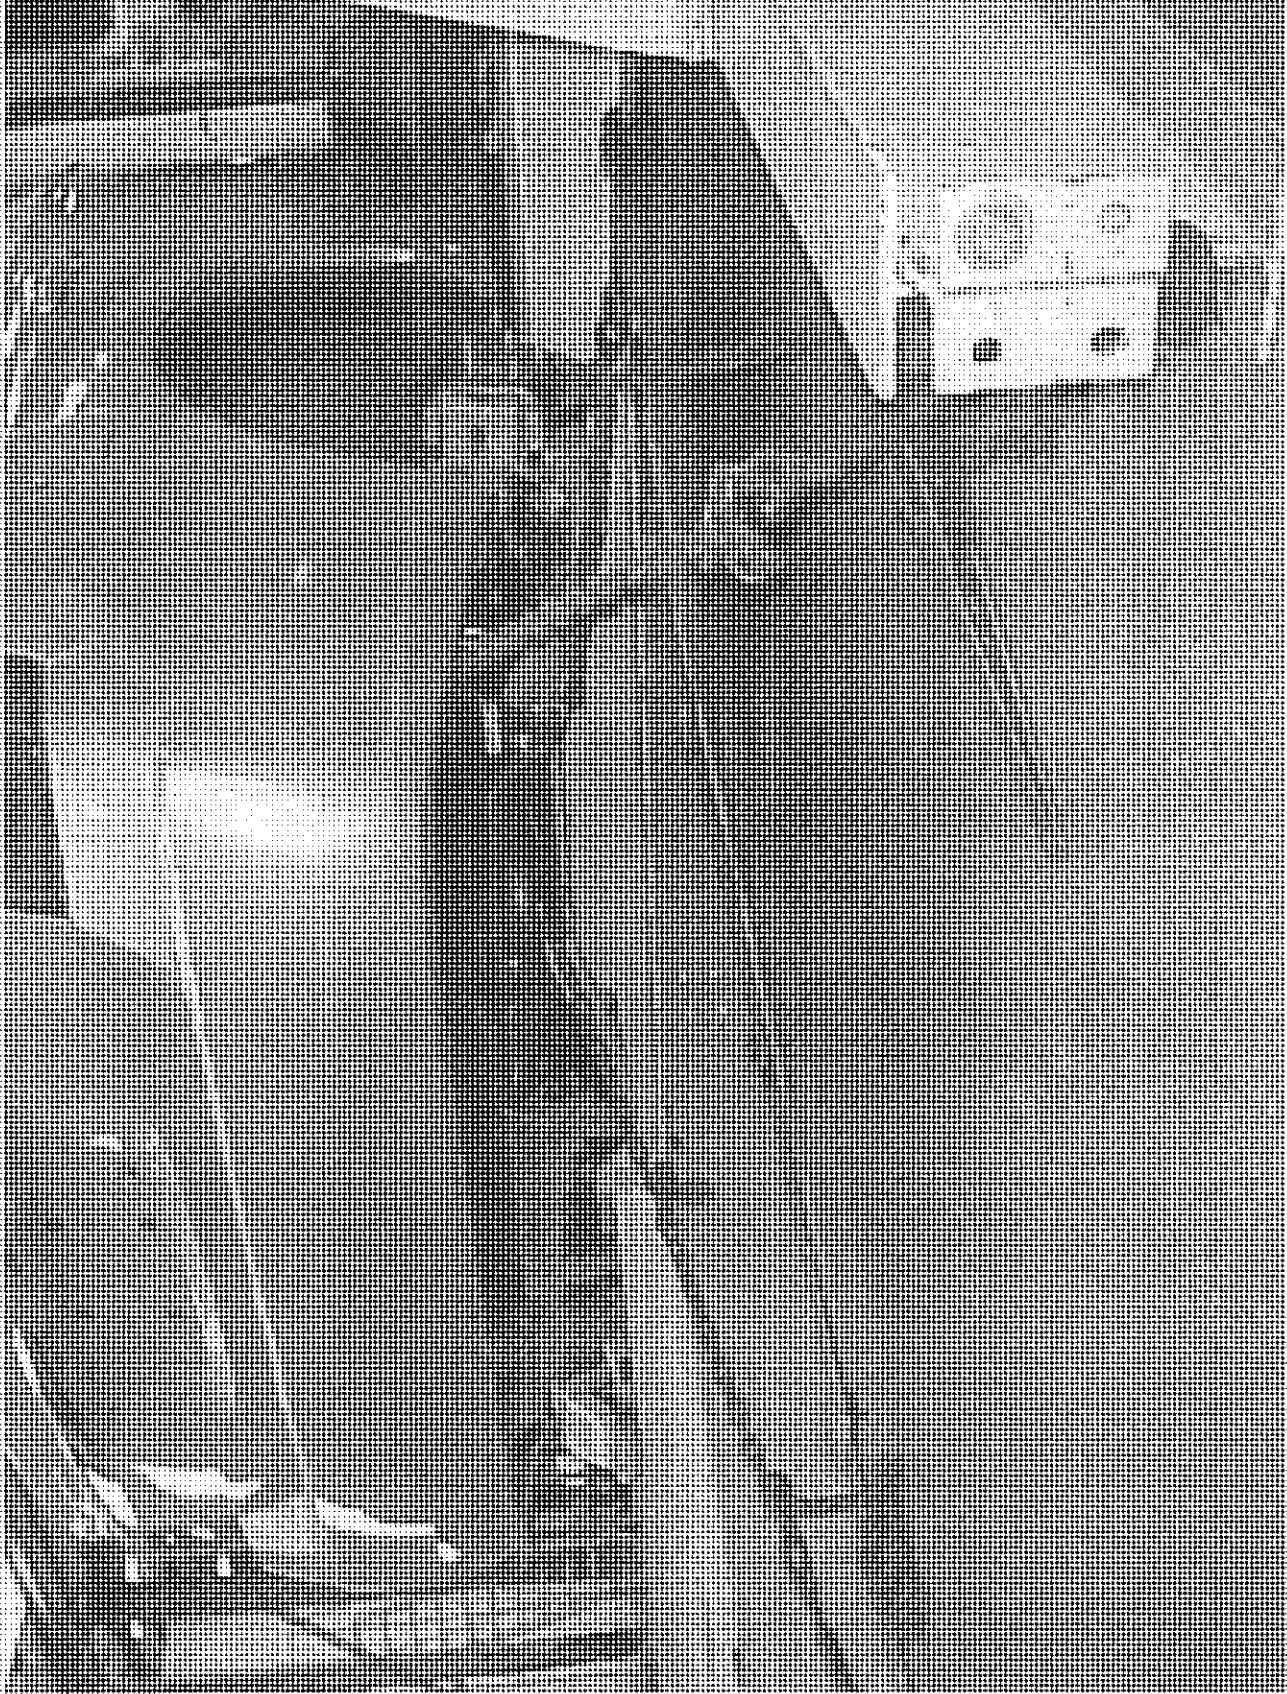
FIGURE 6-21  
REAR VEHICLE TIE DOWN - TEST 2

| SECTION | | PAGE |
|---|---|---|
| | 5.21 Rear Vehicle Tie Down - Test 2 | |

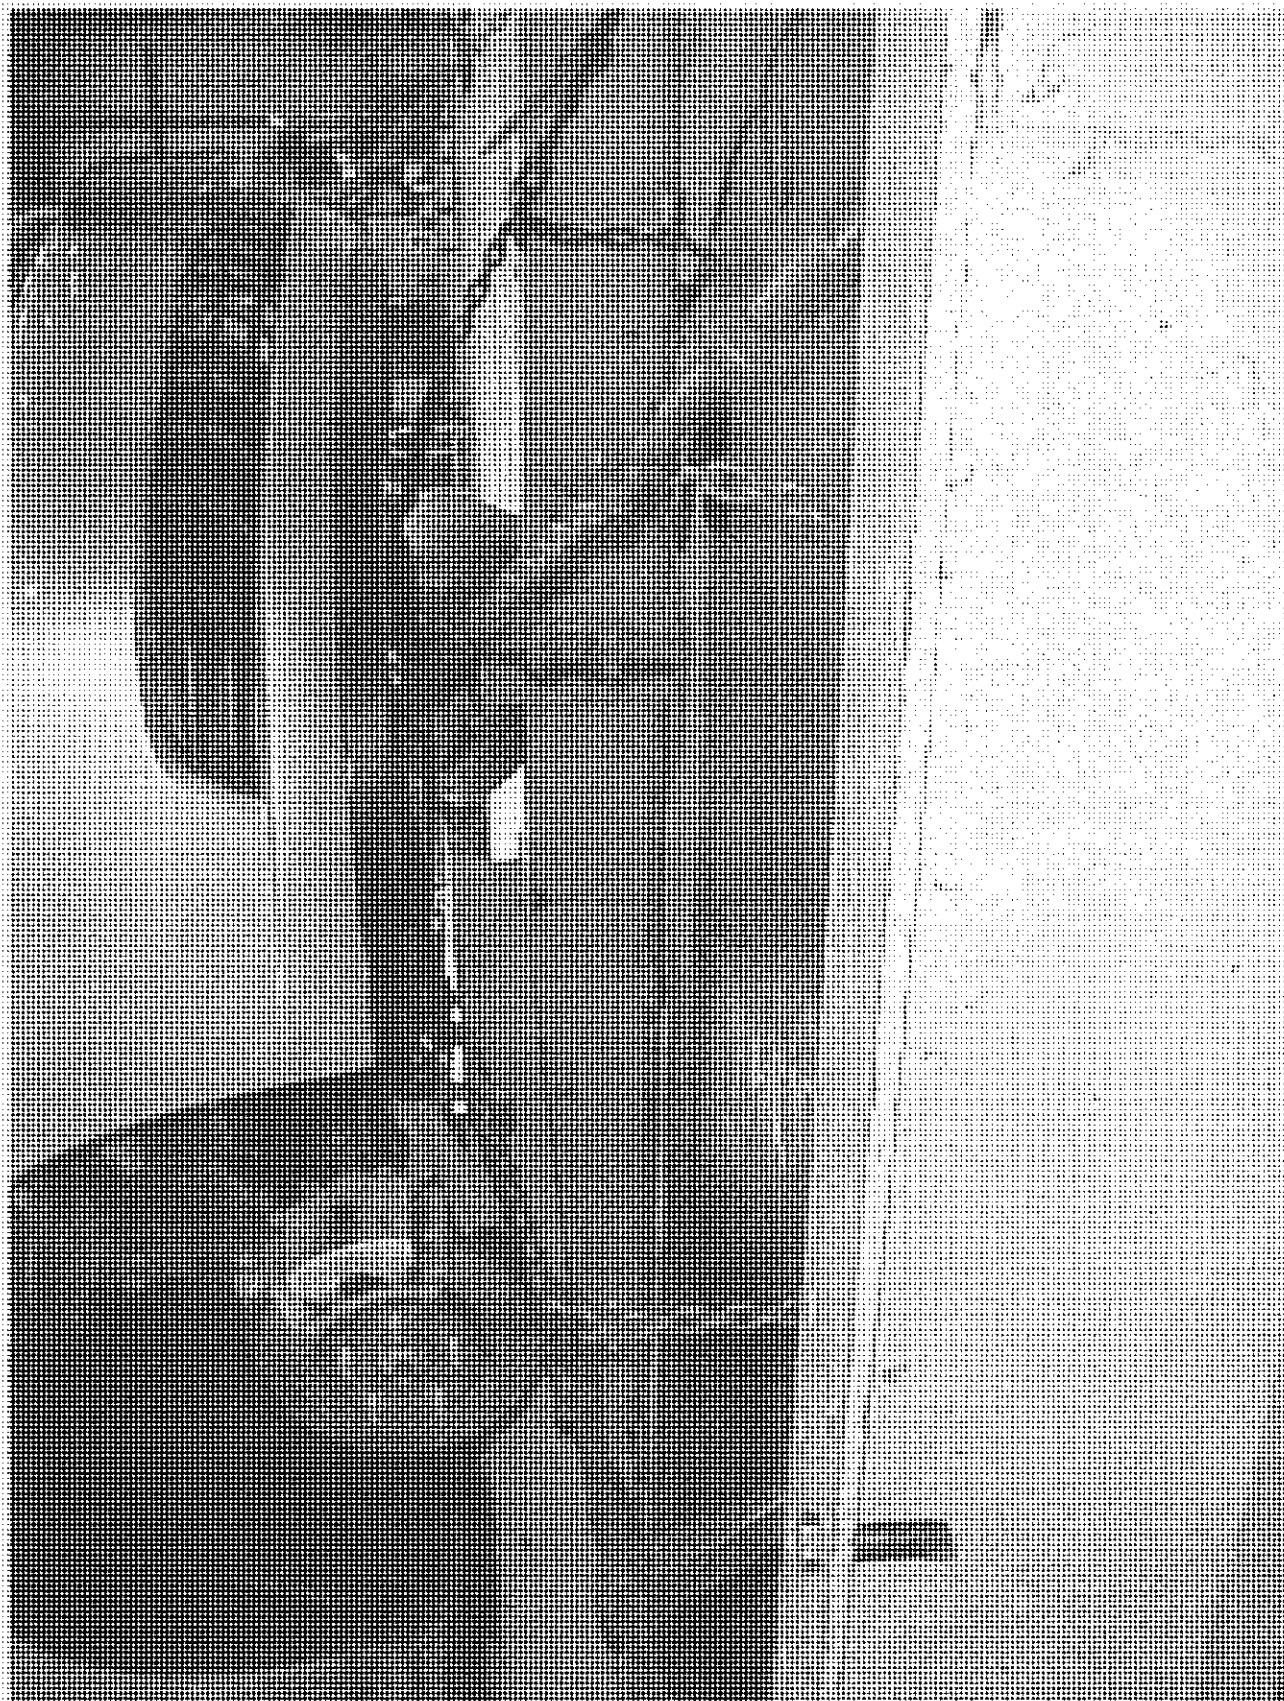
FIGURE 5.22  
FRONT VEHICLE TIE DOWN TEST 2

| SECTION | | PAGE |
|---|---|---|
| | 5.22 Front Vehicle Tie Down - Test 2 | |

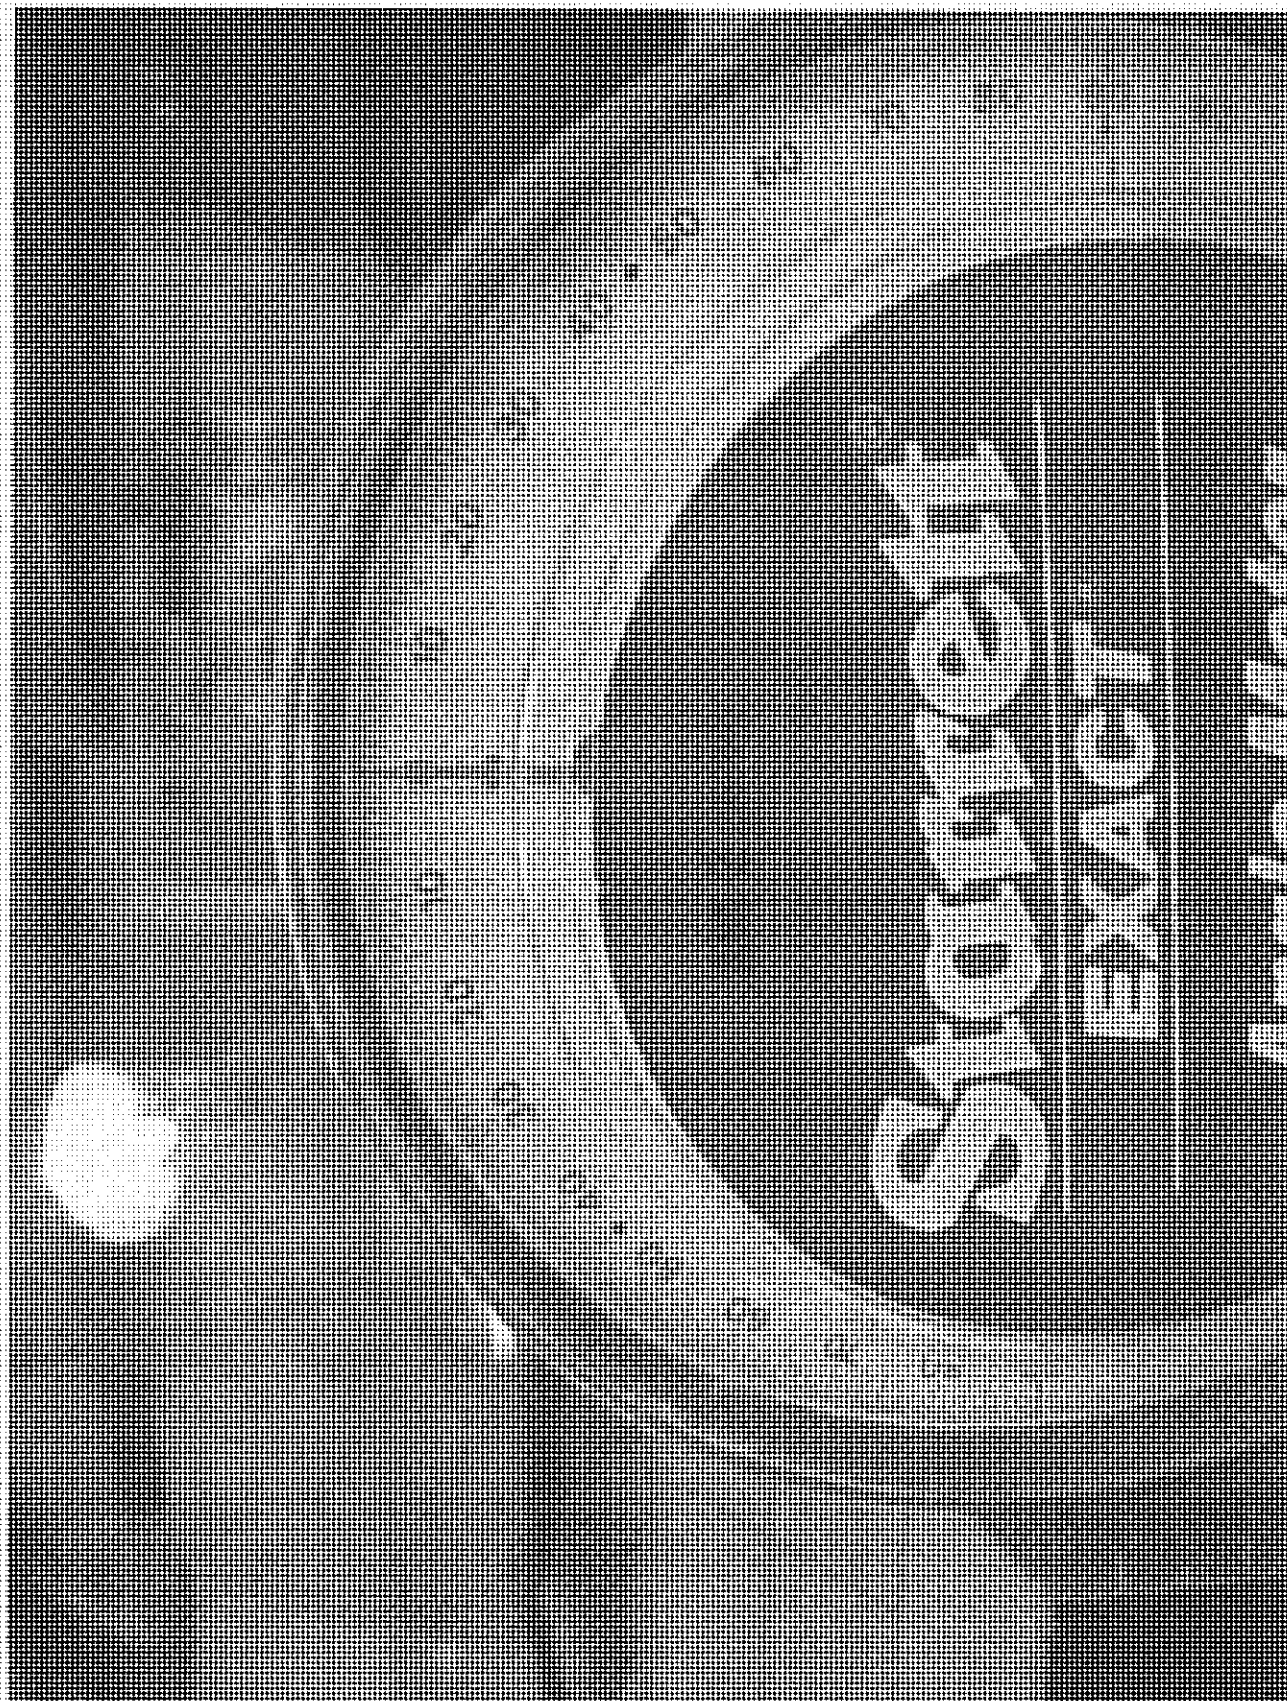
FIGURE 5.23  
INCLINOMETER PRE-TEST 2

| SECTION | | PAGE |
|---|---|---|
| | 5.23 Inclinator Pre-Test 2 | |

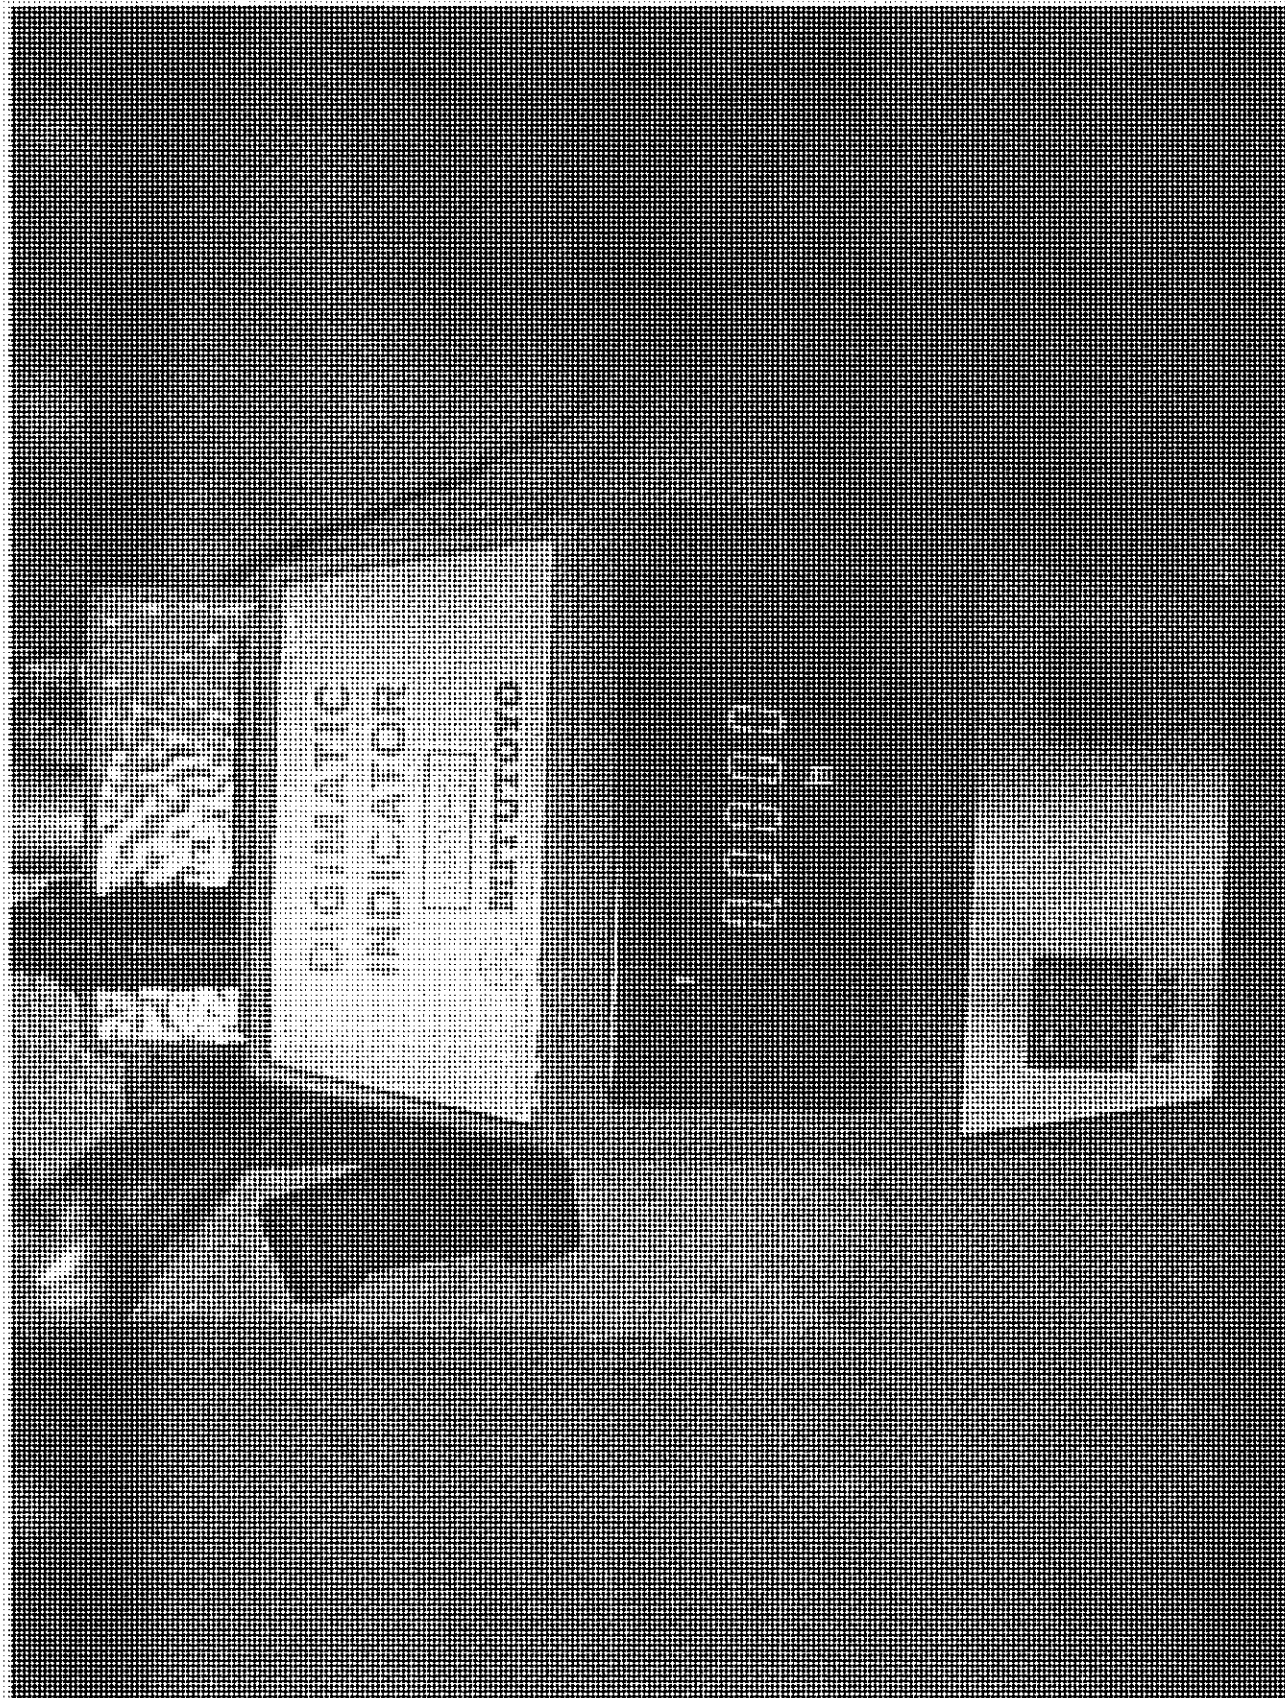
FIGURE 5.24  
DIAL INDICATOR PRE-TEST - 2

| SECTION | | PAGE |
|---|---|---|
| | 5.24 Dial Indicator Pre-Test 2 | |

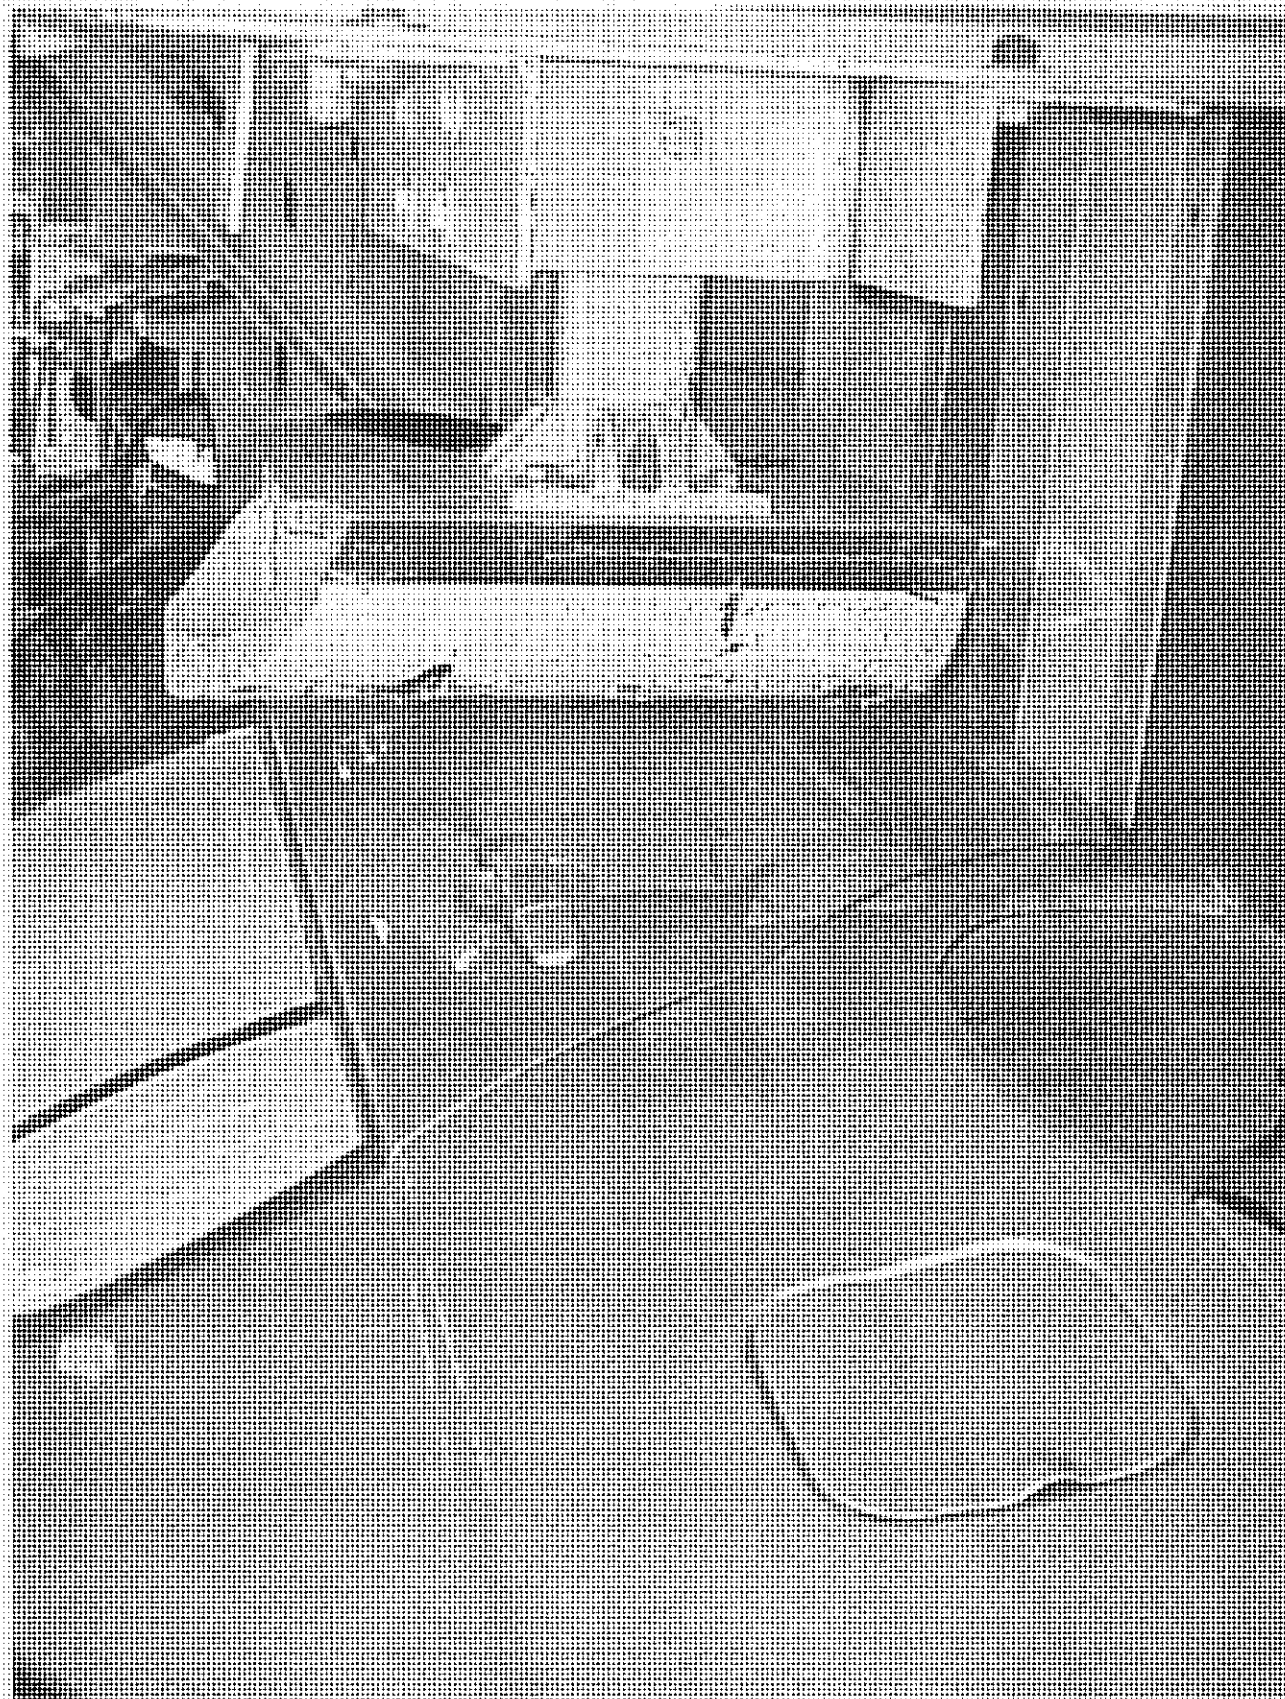
FIGURE 5.25  
LOAD DEVICE AGAINST DOOR - PRE-  
"TEST" 2

| SECTION | | PAGE |
|---|---|---|
| | 5.25 Load Device against Door - Pre-Test 2 | |
